# **Project Profile**

**February 27, 2018**

# Superstore sound barrier doubles as retaining wall in London, Ontario

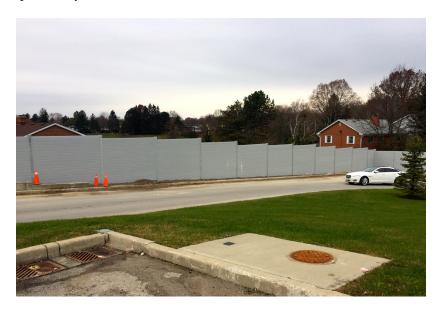
The Real Atlantic Superstore (Choice Properties REIT) needed to replace an existing concrete sound barrier wall that had deteriorated from freeze-thaw cycles. The original wall also acted as a bit of a retaining wall and, not having been designed for that, was leaning quite badly.

The consultant specified lightweight PVC AIL Sound Walls for the replacement sound barrier wall and we developed some specialized concrete panels at the base to provide the required soil-retaining properties.

Because the PVC panels are not strong enough to retain the soil, we designed special concrete base panels to integrate into our steel post system and had them produced by our partners at MSE Precast. Also, because of the poor soil quality, extra-deep, direct-bury footings were used.
